**INFRARED INSPECTION REPORT SUMMARY**

CUSTOMER NAME	
Steel Casting Plant 1234 Main Street Anytown, USA 12345

DATE OF INSPECTION	July 12 through 14, 2011
INSPECTION PERFORMED BY	John Woska
ASSISTANCE PROVIDED BY	Vince of Scantek
SUGGESTED FOLLOW UP INSPECTION PERIOD	Three to Six Months

# THERMOGRAPHIC REPORT

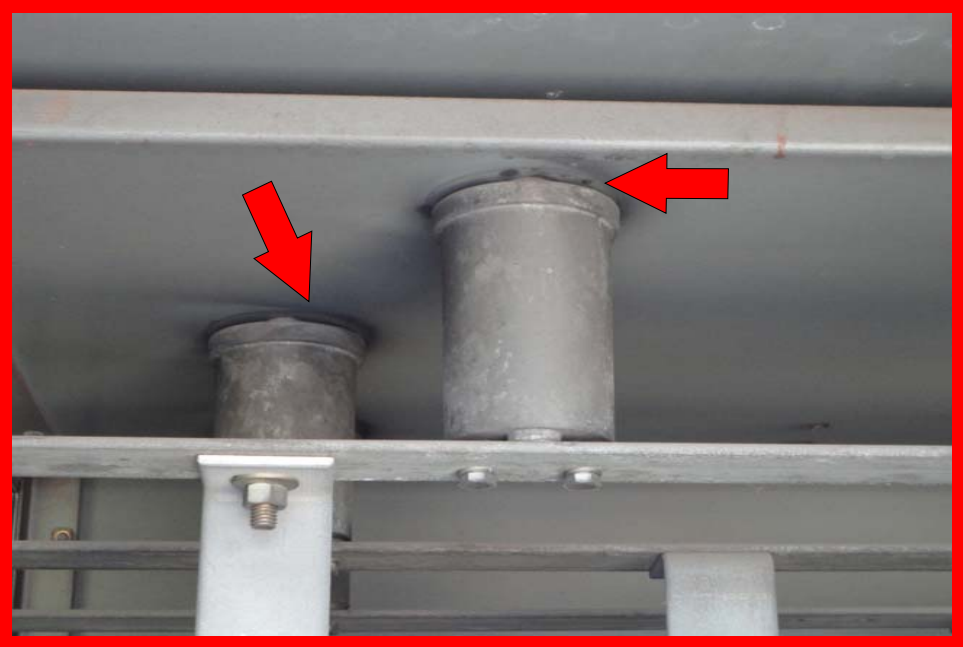
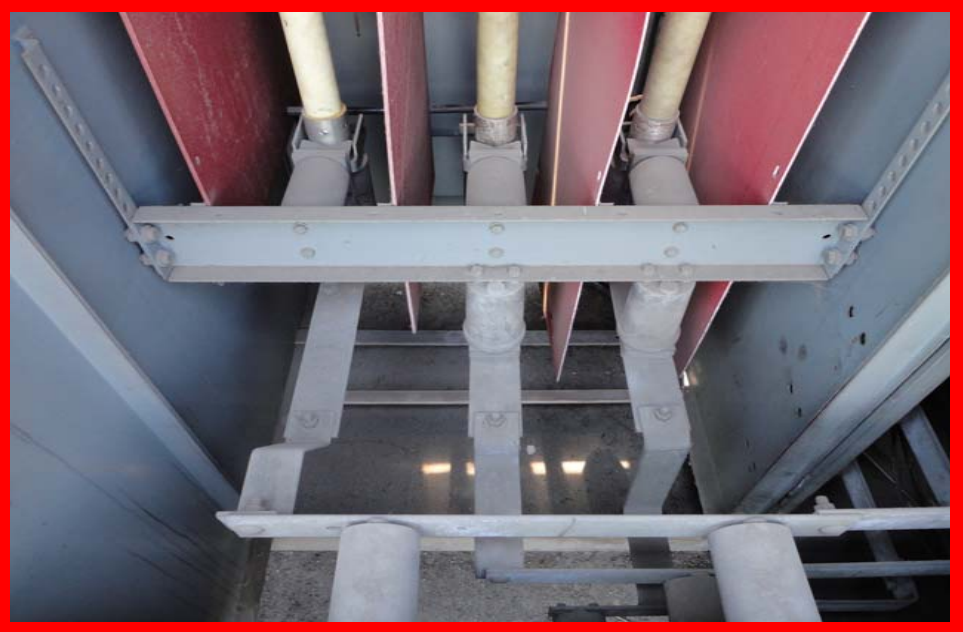
PROBLEM NO.1

**EQUIPMENT** : North 15kV Metalclad Switchgear, Second and Third Doors From East, Main Switchgear Bay (Rear View)

**PROBLEM** : Visual signs of previous corona tracking. All insulators and buss are extremely dirty.  
**NOTE:** Previous problem No.1 from report dated August 2010

**COMMENTS** : Recommend complete switchgear cleaning

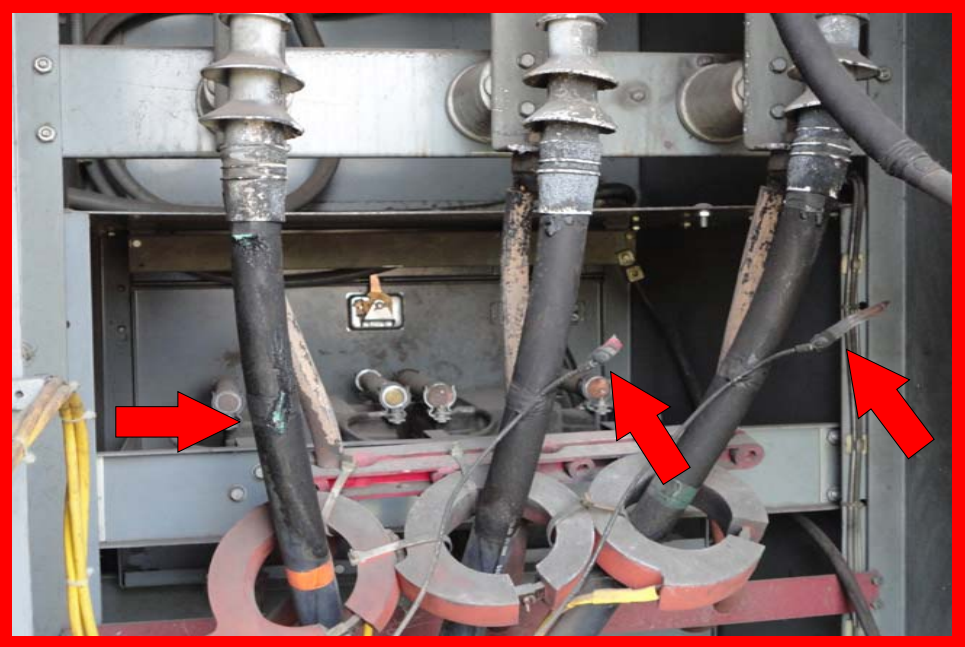
PROBLEM NO.2

**EQUIPMENT** : North 15kV Metalclad Switchgear, East Door, Main Incoming Conductor Set (Rear View)

**PROBLEM** : All three concentric ground bleed straps blown in half at conductor stress cone connection areas

**COMMENTS** : Address as required

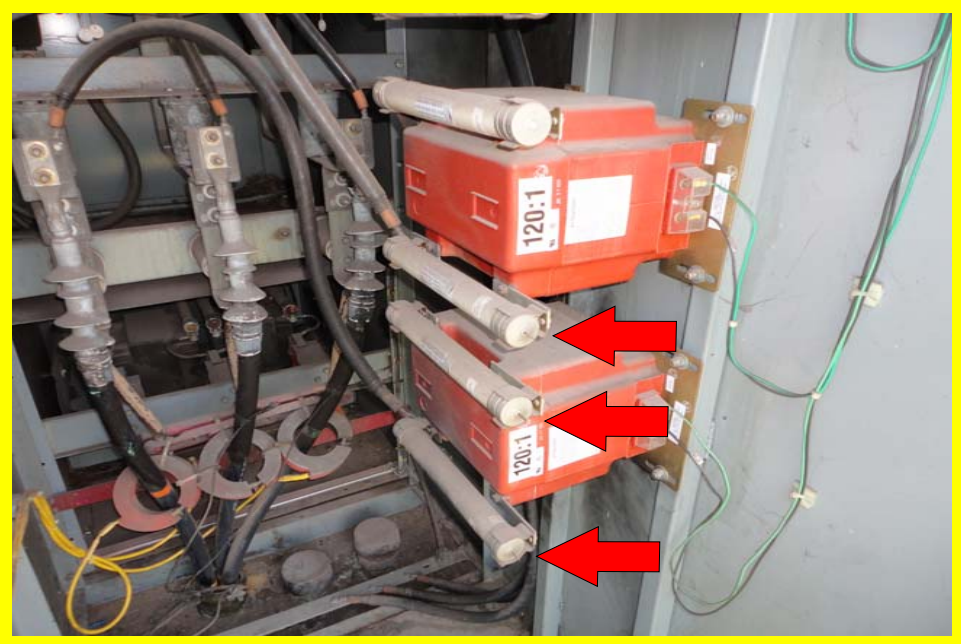
PROBLEM NO.3

**EQUIPMENT** : North 15kV Metalclad Switchgear, East Door, Rear Mounted Potential Transformer Set (Rear View)

**PROBLEM** : "Blown Fuse" indicators on bottom three fuses

**COMMENTS** : Address as required

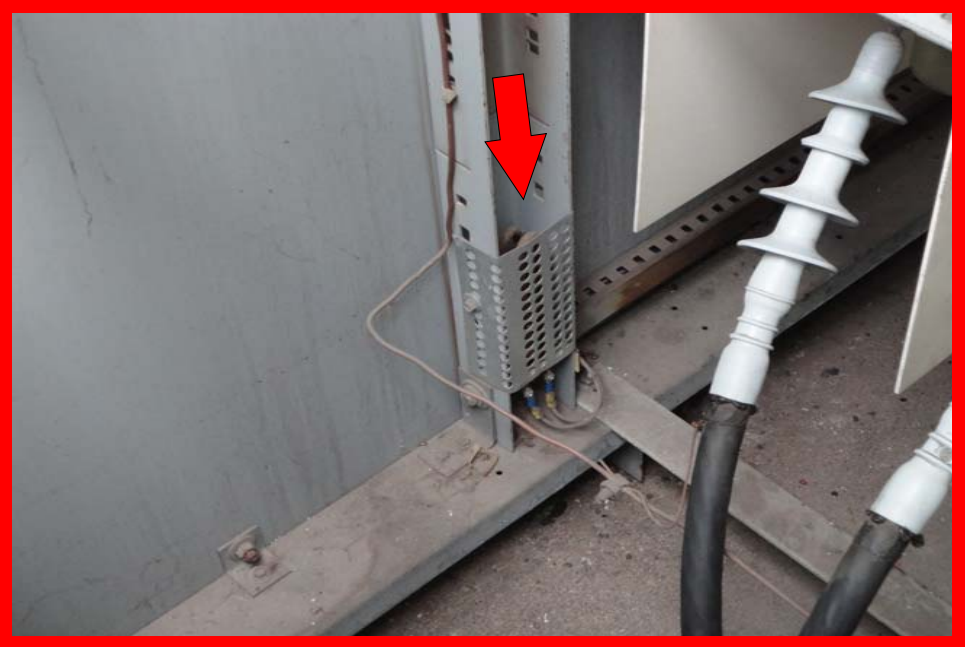
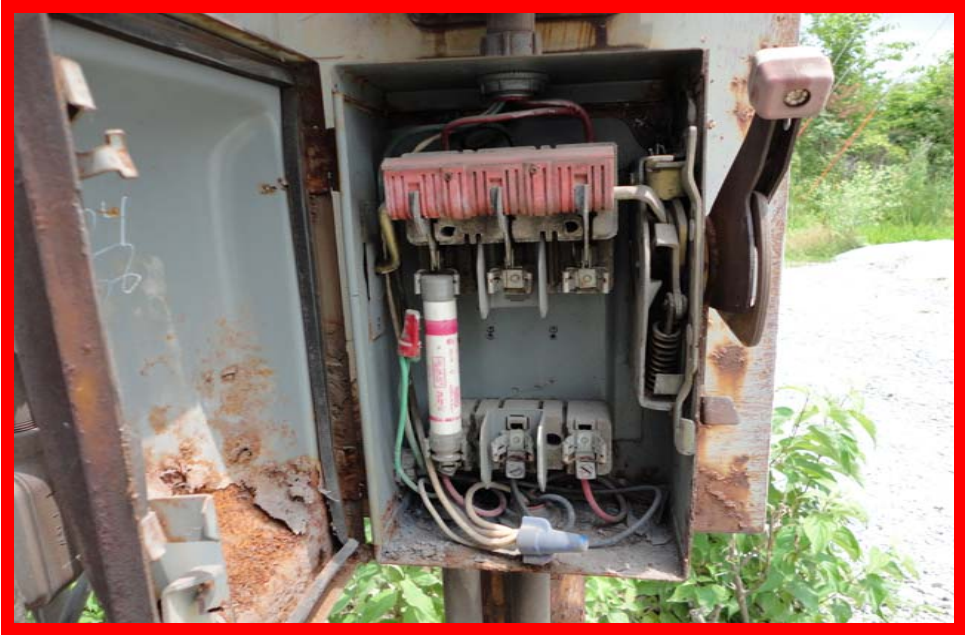
PROBLEM NO.4

FIELD TECHNICIAN'S COMMENTS
Problems No.4 and No.5 show cabinet heater failures in the North15kV Metalclad Switchgear and Utility Metalclad Switchgear. The importance of failed cabinet heaters should not be taken lightly as the results of unchecked moisture within this gear can be catastrophic to the gear itself, production, and the safety of plant personnel. Cabinet heaters and heater strips should be inspected and repaired on a priority basis. Investigate possibility of installing amperage meters on high voltage switchgear bay heaters for easy visual reference of heater operation.

**EQUIPMENT** : North 15kV Metalclad Switchgear, West Adjacent Metalclad Switchgear For "500kVA & 1500kVA Outside Shell Shop"

**PROBLEM** : Top Photograph: Cabinet heater inoperable.  
Bottom Photograph: Control power fuse in 30A disconnect appears operational.  
**NOTE:** See technician's comments

**COMMENTS** : Investigate reason for non-operation; correct as required

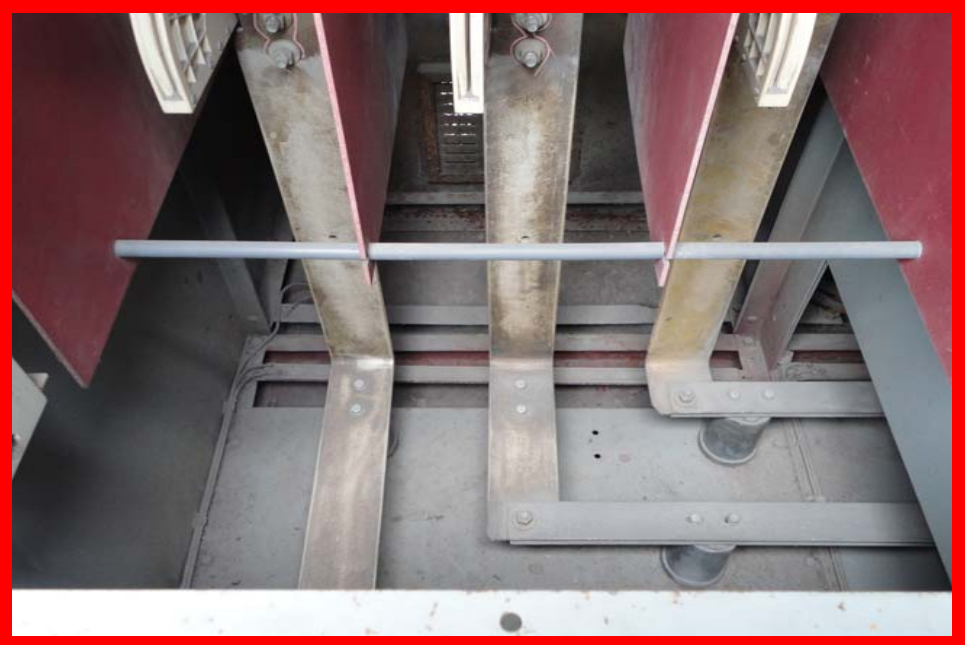
PROBLEM NO.5

**EQUIPMENT** : Utility Metalclad Switchgear, Center Bay, Bottom Heater Strip

**PROBLEM** : Heater strip inoperable. Heaters inoperable in adjacent bays  
**NOTE:** See technician's comments

**COMMENTS** : Investigate reason for non-operation; correct as required

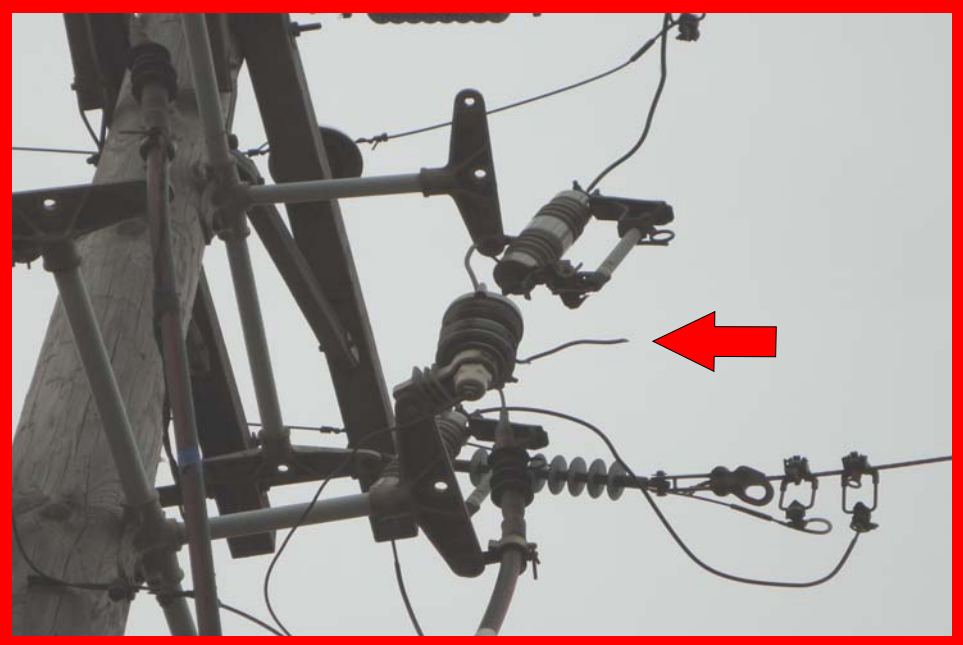
PROBLEM NO.6

**EQUIPMENT** : Northwest Power Pole Service Drop, Lighting Arrestor Set, Center  $\emptyset$  Arrestor

**PROBLEM** : Top arrestor conductor severed from buss; compromising protection

**COMMENTS** : Contact local utility company to address as required

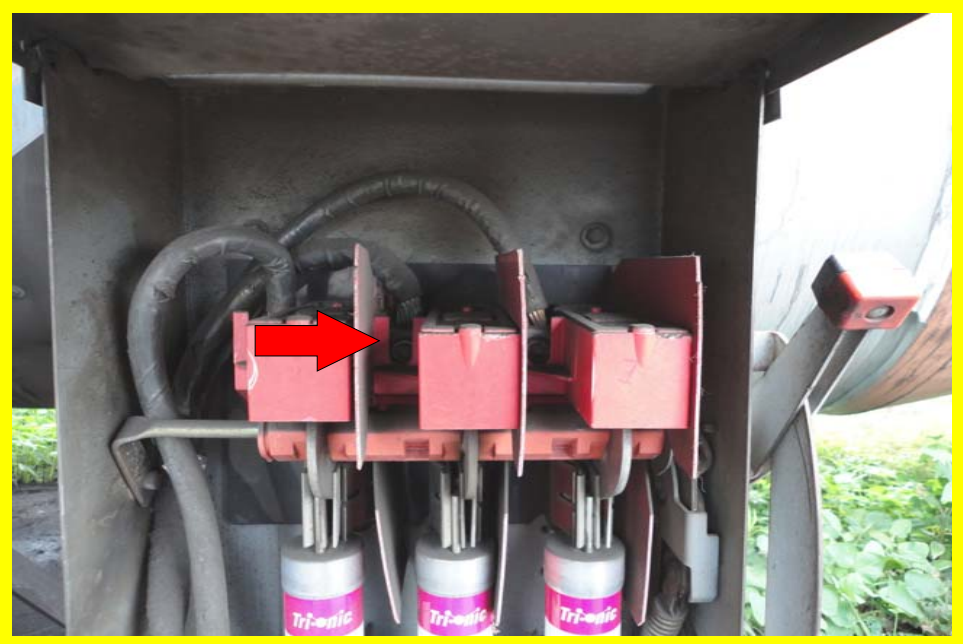
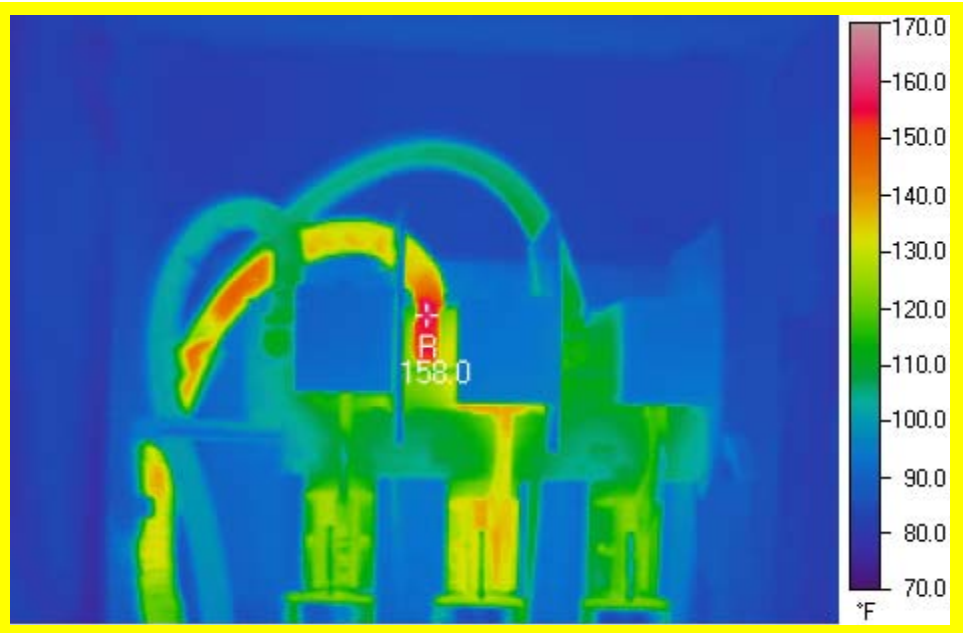
PROBLEM NO.7

**EQUIPMENT** : Induction Furnace Dust Collector 200A Fused Disconnect

**PROBLEM** : Line side, center  $\varnothing$  conductor lug connection area showing a 57°F rise over adjacent phases at 111A loading.  
**NOTE:** Previous problem No.4 from report dated August 2010

**COMMENTS** : Rebuild or replace entire disconnect

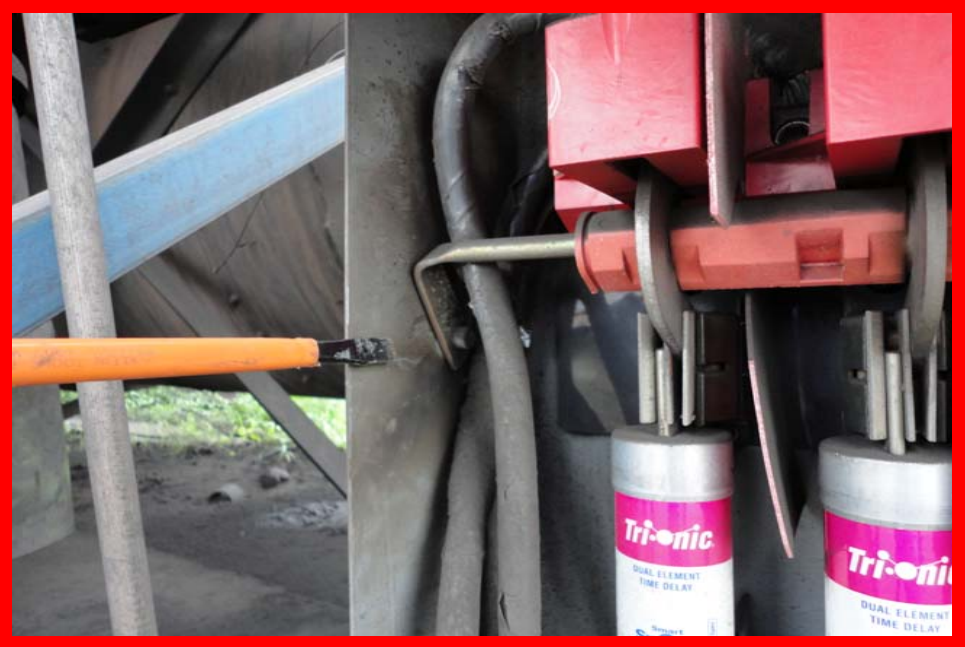
PROBLEM NO.8

**EQUIPMENT** : Induction Furnace Dust Collector 200A Fused Disconnect

**PROBLEM** : Evidence of arcing due to interference of conductor with switch mechanism

**COMMENTS** : Completely disconnect power before checking for interference issues. Rebuild or replace entire disconnect. Address as required

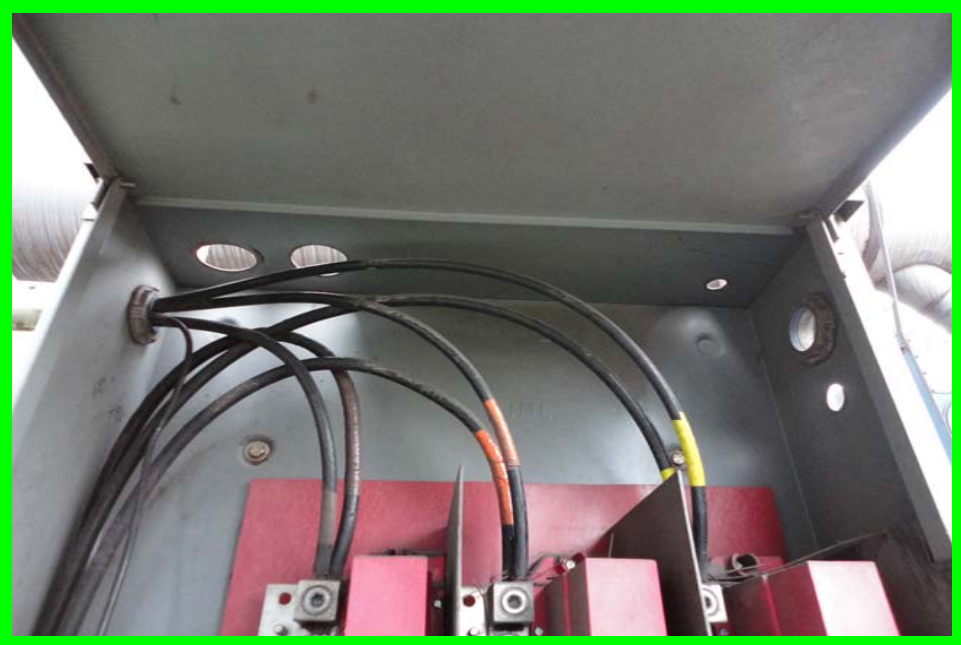
PROBLEM NO.9

**EQUIPMENT** : Unlabeled 400A Disconnect (Top Lugs Only)

**PROBLEM** : Multiple knockouts missing. Evidence of bird inhabitation

**COMMENTS** : Address as required

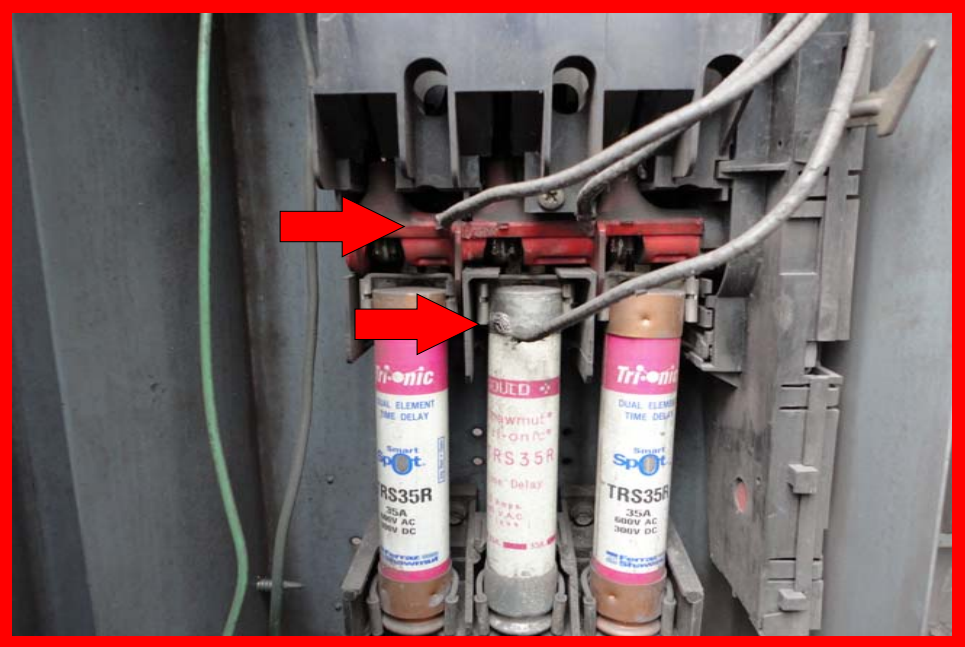
PROBLEM NO.10

LOCATION : Outside of Foundry Building, South End  
EQUIPMENT : No.7 Dust Collector 60A Disconnect  
PROBLEM : Unattached conductors resting on energized parts of disconnect assembly  
COMMENTS : Address as required  
DATE & TIME : 7/13/11 @ 8:50AM

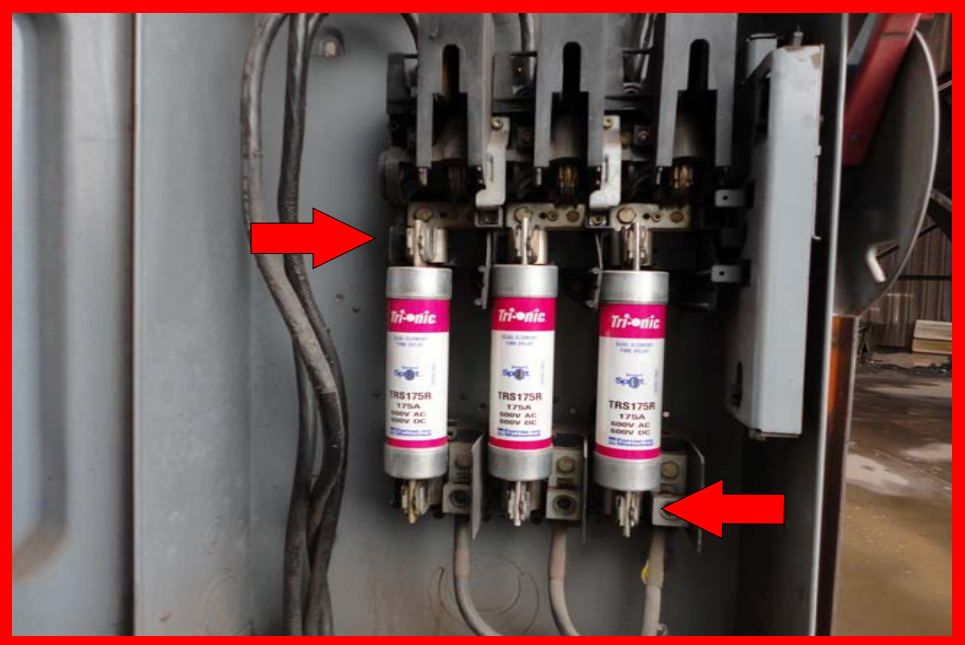
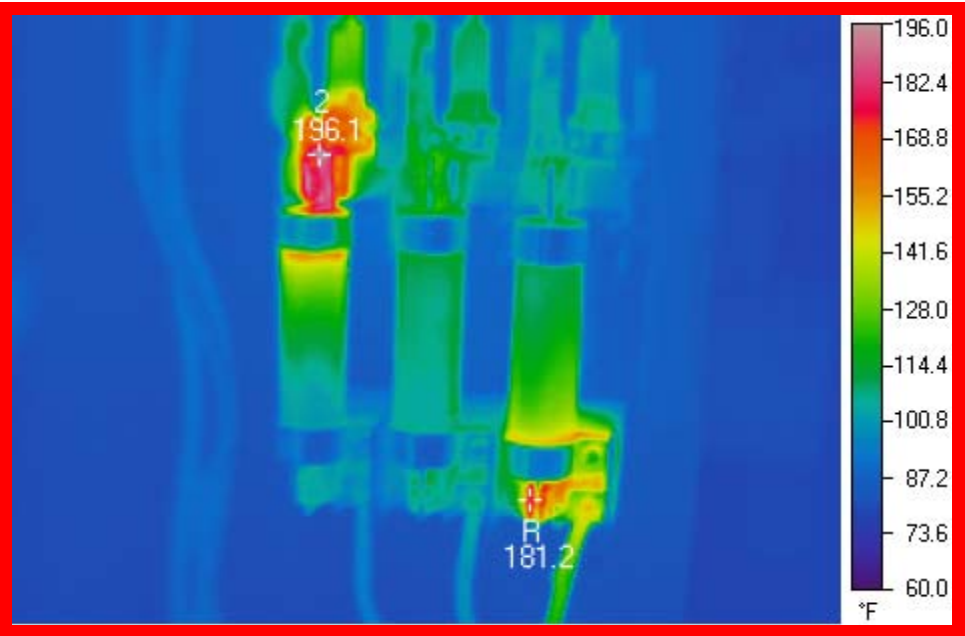
PROBLEM NO.11

EQUIPMENT : No.3 Dust Collector 200A Disconnect

PROBLEM : Line side, left  $\phi$  and load side, right  $\phi$  fuse clip areas showing 90°F to 110°F rises over center phase at 74A loading.  
NOTE: Amperage reading at time of inspection: A $\phi$ :74, B $\phi$ :74, and C $\phi$ :74

COMMENTS : Clean all fuse ends and clip surfaces and/or restore proper clip tension as required. Inspect, clean fuse clip surfaces, checking for fuse clip tension and fuse bracket screw(s) tightness

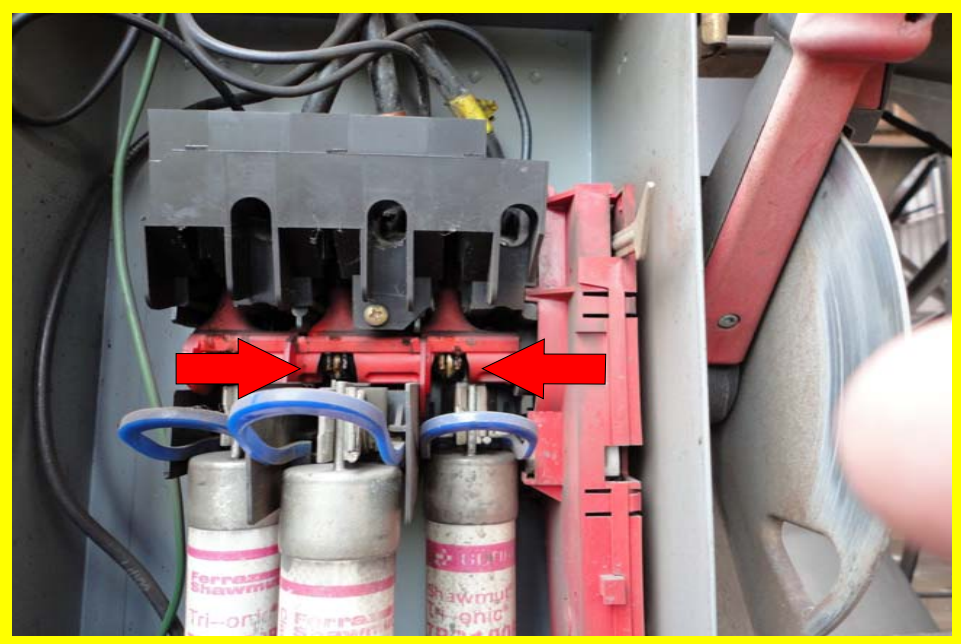
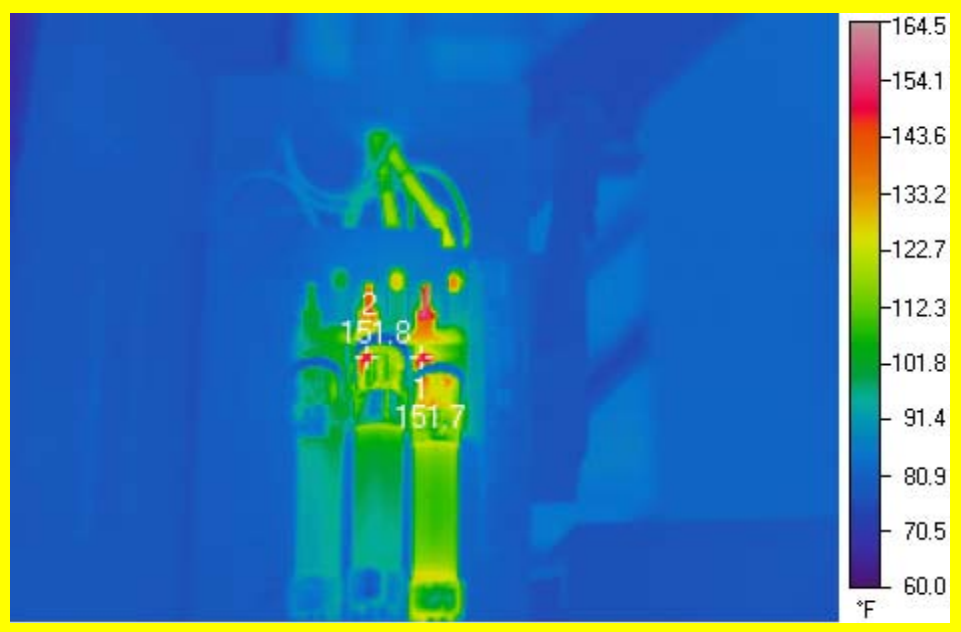
PROBLEM NO.12

**EQUIPMENT** : No.2 Dust Collector 100A Disconnect

**PROBLEM** : Line side, center  $\phi$  and right  $\phi$  contact arm pivot point areas showing 56°F rises over adjacent phase at 39A loading.  
**NOTE:** Amperage reading at time of inspection: A $\phi$ :39, B $\phi$ :39, and C $\phi$ :39

**COMMENTS** : Clean, inspect, and tighten all associated contacting/connection points of disconnect assembly. Rebuild or replace entire disconnect

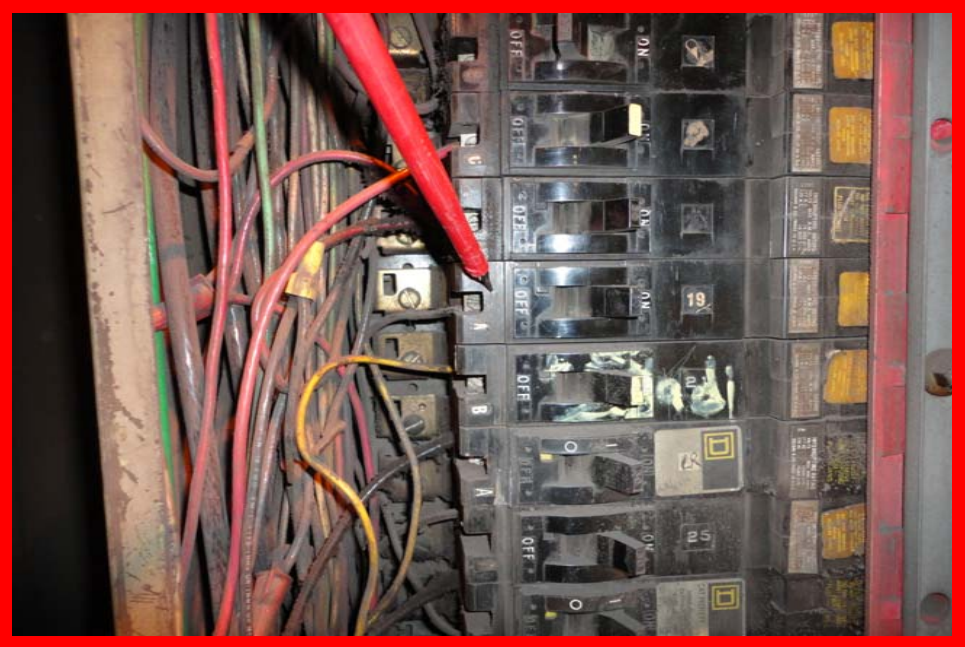
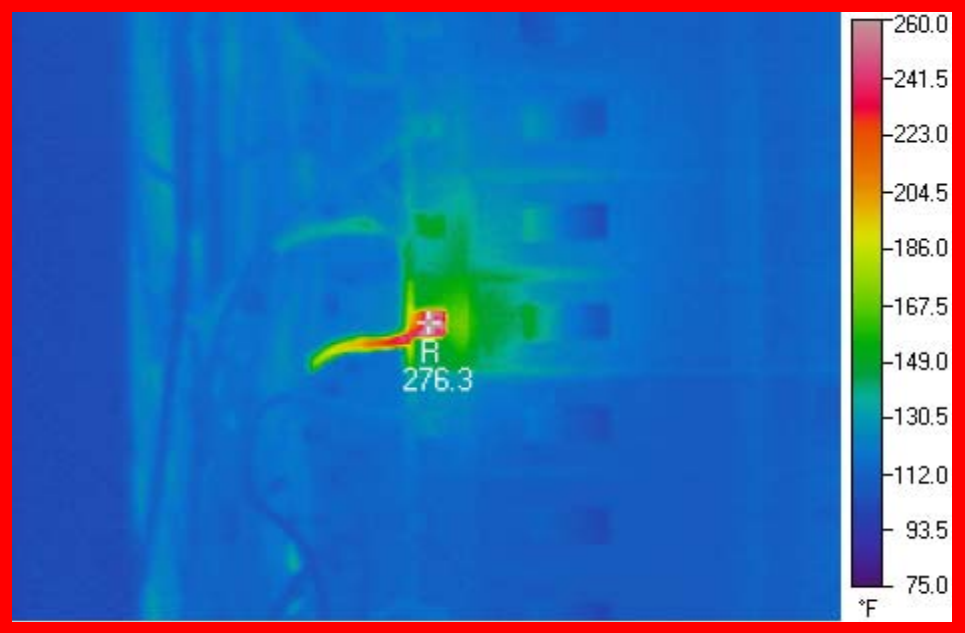
PROBLEM NO.13

**EQUIPMENT** : No.4 Breaker Panel, No.19 30A Breaker

**PROBLEM** : Load side, conductor lug connection area showing a 178°F rise over adjacent phases.  
**NOTE:** Insulation badly damaged

**COMMENTS** : Problem addressed as time of discovery; further attention required. Check for oxidation, and cut back if required and clean and tighten

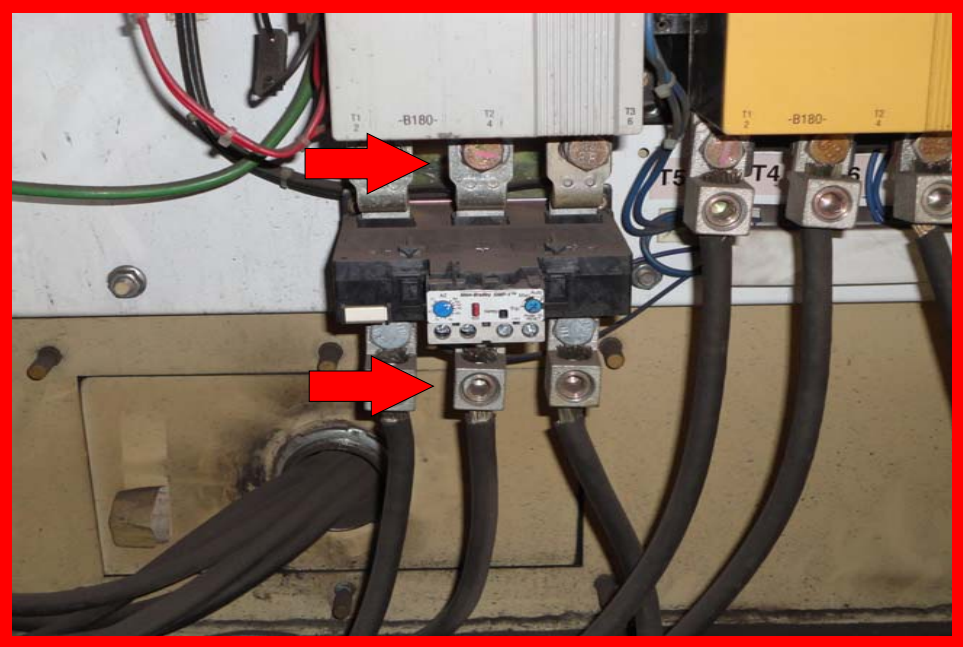
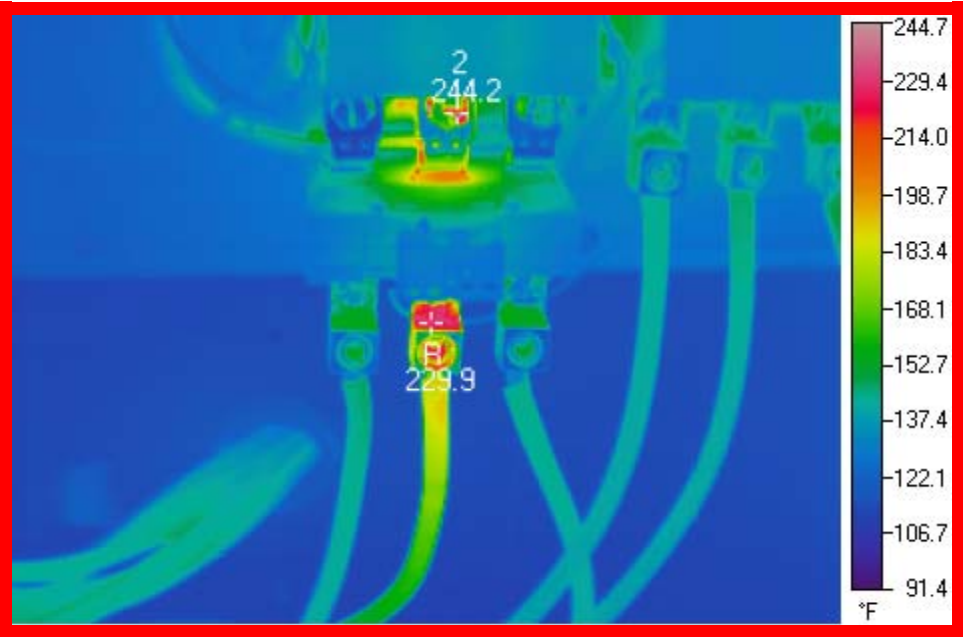
PROBLEM NO.14

**EQUIPMENT** : No.200 Air Compressor Motor Control Cabinet, Left Main Starter Assembly

**PROBLEM** : Load side, center  $\varnothing$  conductor lug and overload assembly to contactor bolted connection areas showing 100°F to 115°F rises over adjacent phases at 223A loading

**COMMENTS** : Disassemble, clean, dress all points, and reassemble torquing to spec. Inspect for cause of heating and repair or replace as required

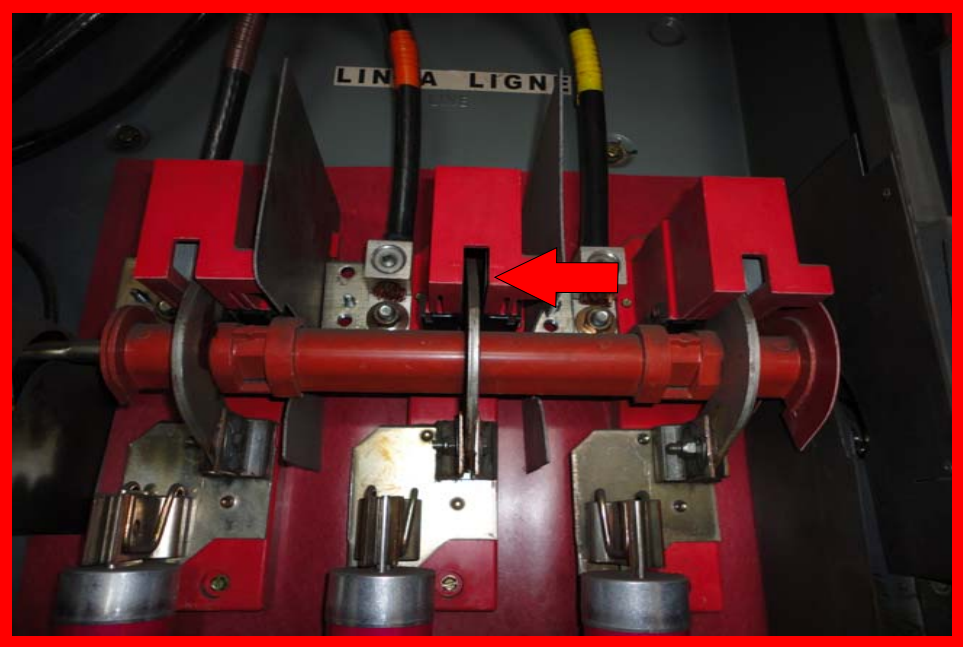
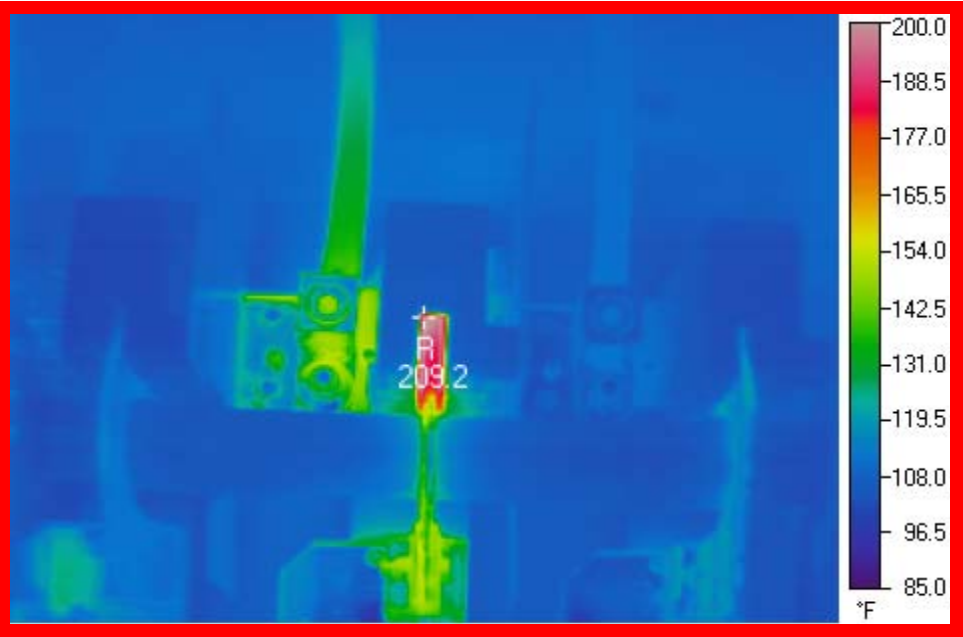
PROBLEM NO.15

**EQUIPMENT** : South 200hp Air Compressor 400A Fused Disconnect

**PROBLEM** : Line side, center  $\emptyset$  contact jaw area showing a 97°F rise over adjacent phases at 220A loading.  
**NOTE:** Switch mechanism questionable

**COMMENTS** : Clean, inspect, and tighten all associated contacting/connection points of disconnect assembly. Rebuild or replace entire disconnect

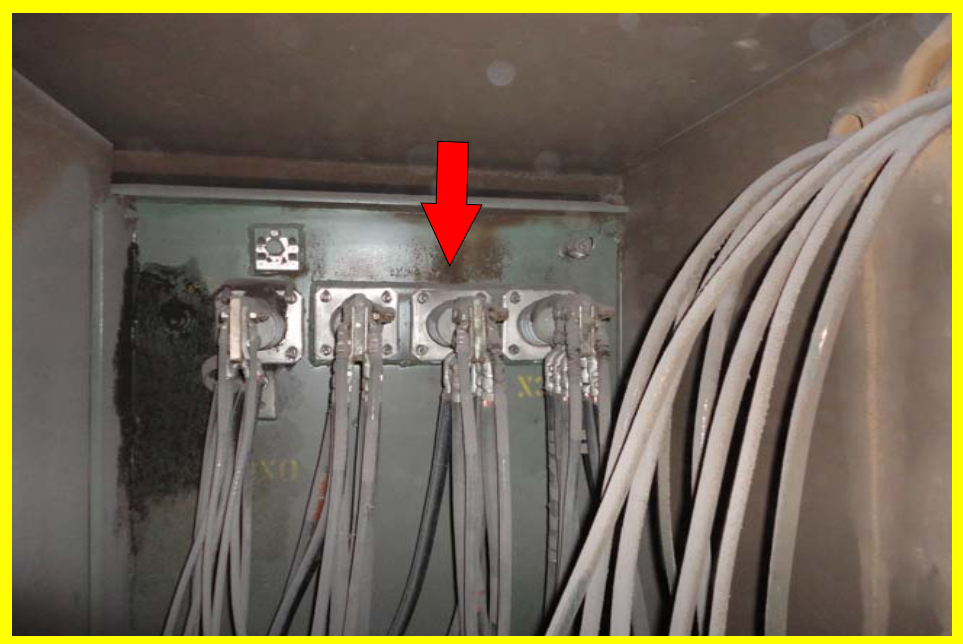
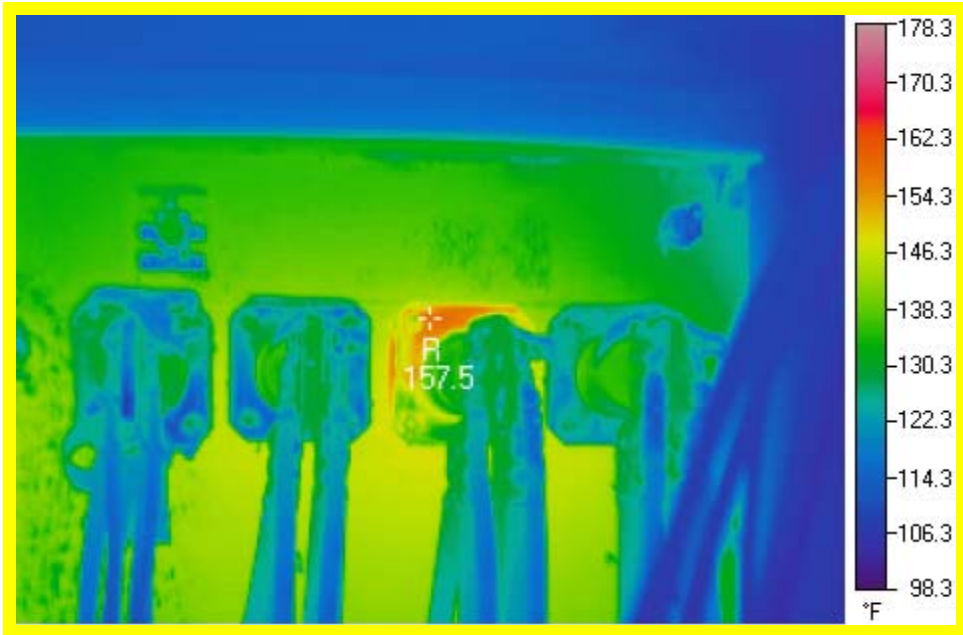
PROBLEM NO.16

**EQUIPMENT** : "Old" Unlabeled Transformer, Secondary Bay, Second From Right Bushing

**PROBLEM** : Indicated bushing base area showing a 35°F rise over adjacent phases, from possible internal resistance connection issues.  
**NOTE:** Previous problem No.11 from report dated August 2010

**COMMENTS** : Recommend full spectrum oil analysis including dissolved gas analysis to establish base line operating conditions. Inspect for cause of heating and repair or replace as required

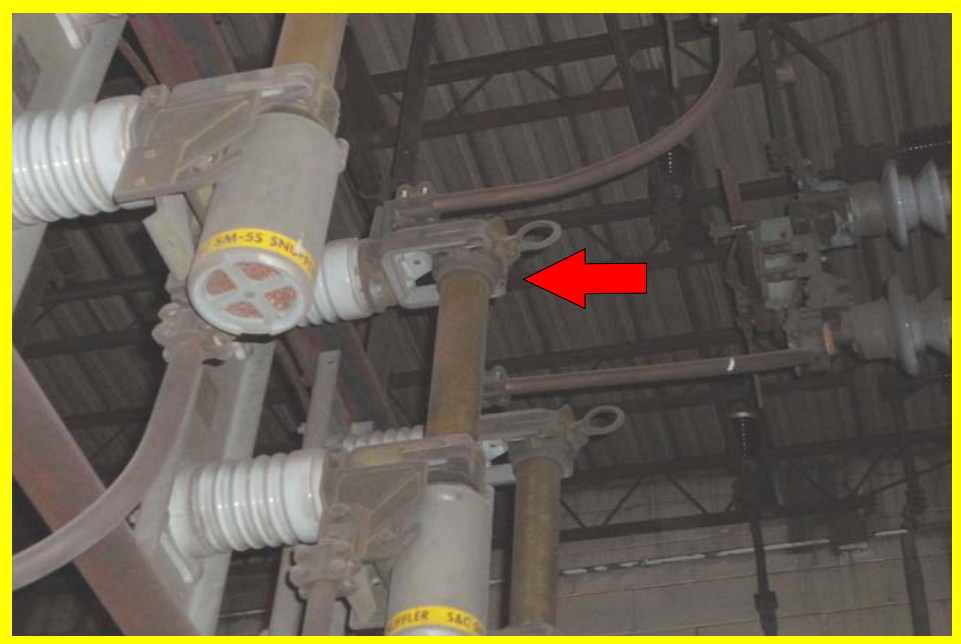
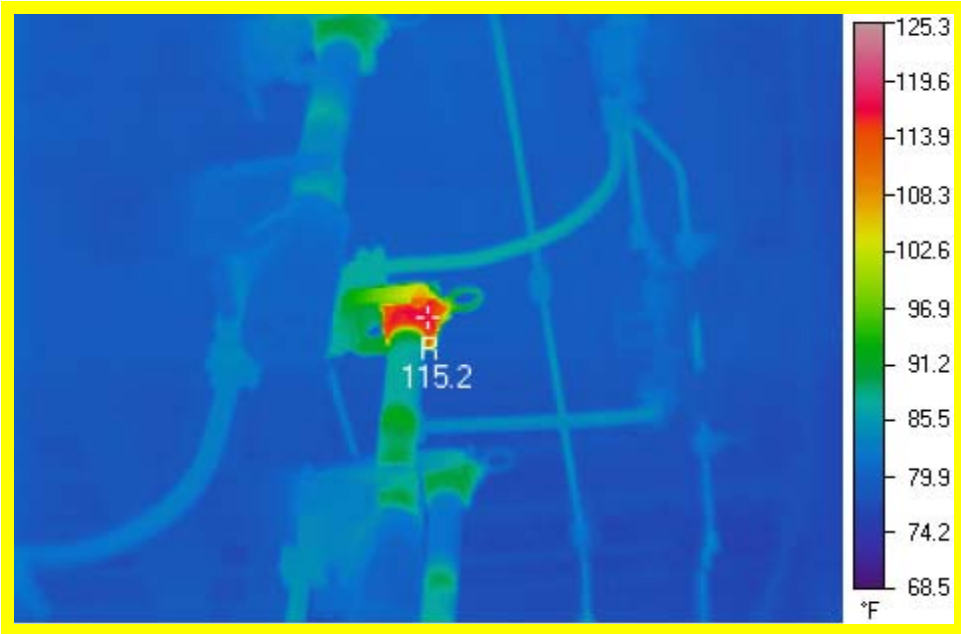
PROBLEM NO.17

**EQUIPMENT** : Three Phase Fuse Set, Center  $\phi$  Fuse

**PROBLEM** : Top of fuse cartridge connection area showing a 36°F rise over adjacent phases.  
**NOTE:** Previous problem No.5 from report dated August 2010

**COMMENTS** : Remake internal fuse element connection of fuse. Clean all fuse ends and clip surfaces and/or restore proper clip tension as required

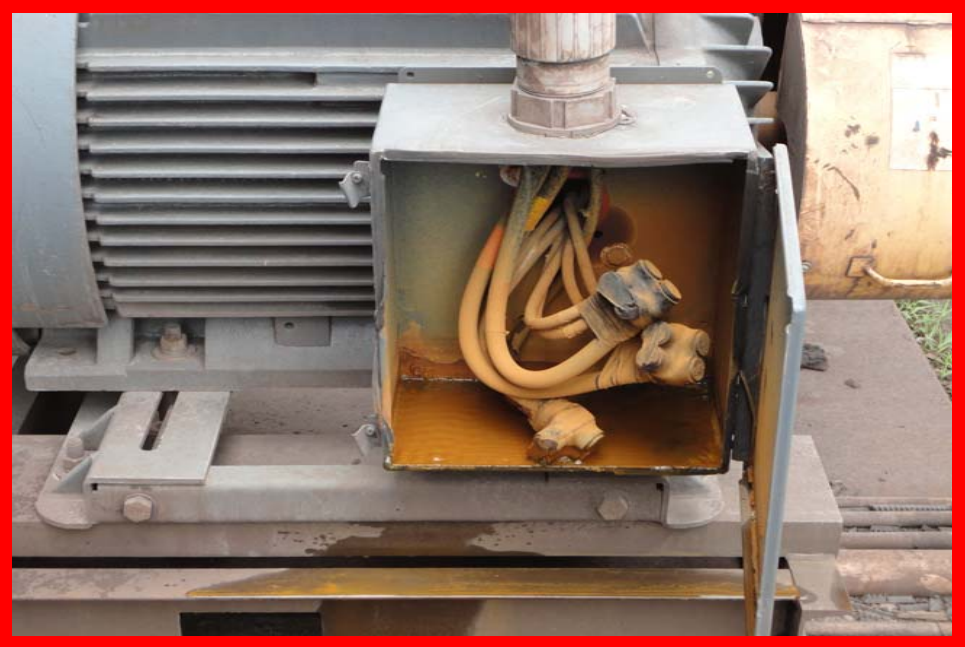
PROBLEM NO.18

**LOCATION** : Outside of Foundry Building, East Side  
**EQUIPMENT** : No.5 Bag House Motor Make-Up Enclosure  
**PROBLEM** : Motor Make-up enclosure filled with water.  
Evidence of high waterline within enclosure  
**COMMENTS** : Address as required  
**DATE & TIME** : 7/13/11 @ 2:33PM

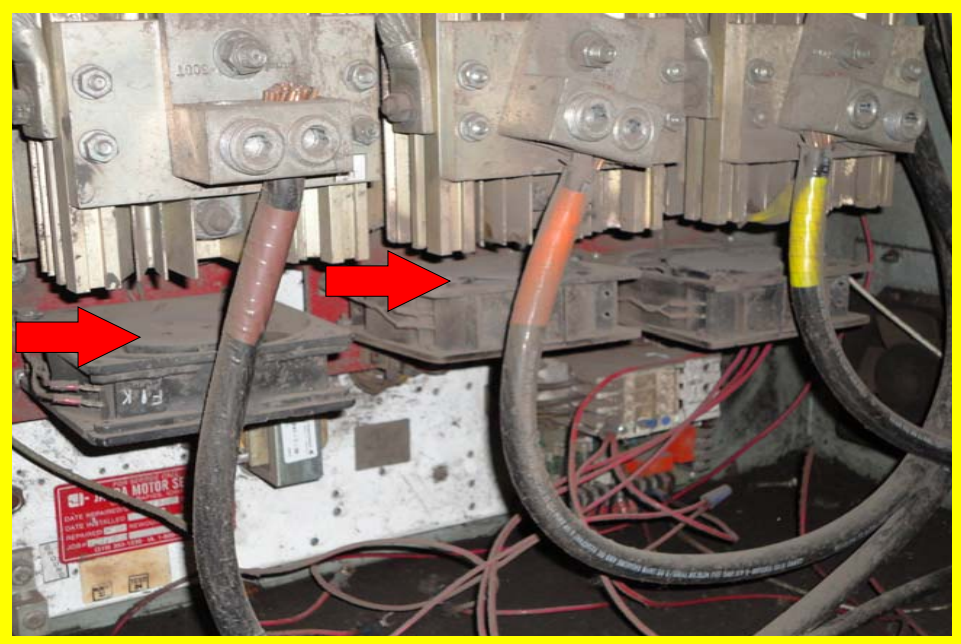
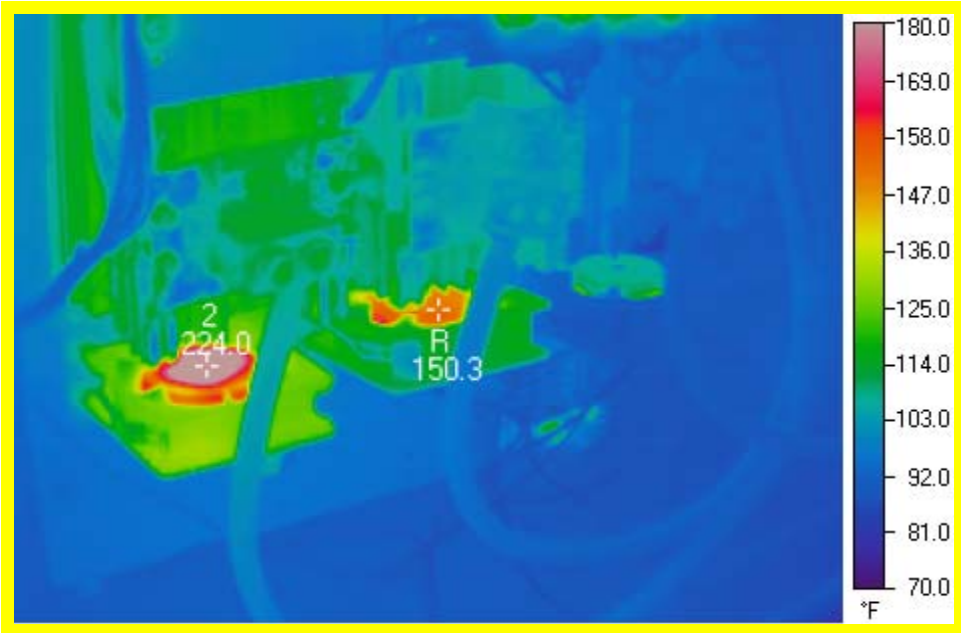
PROBLEM NO.19

**EQUIPMENT** : Unlabeled Soft Start Cabinet, Left and Center Cooling Fans

**PROBLEM** : Indicated cooling fans seized up and showing 150°F to 224°F overall temperatures

**COMMENTS** : Replace cooling fans

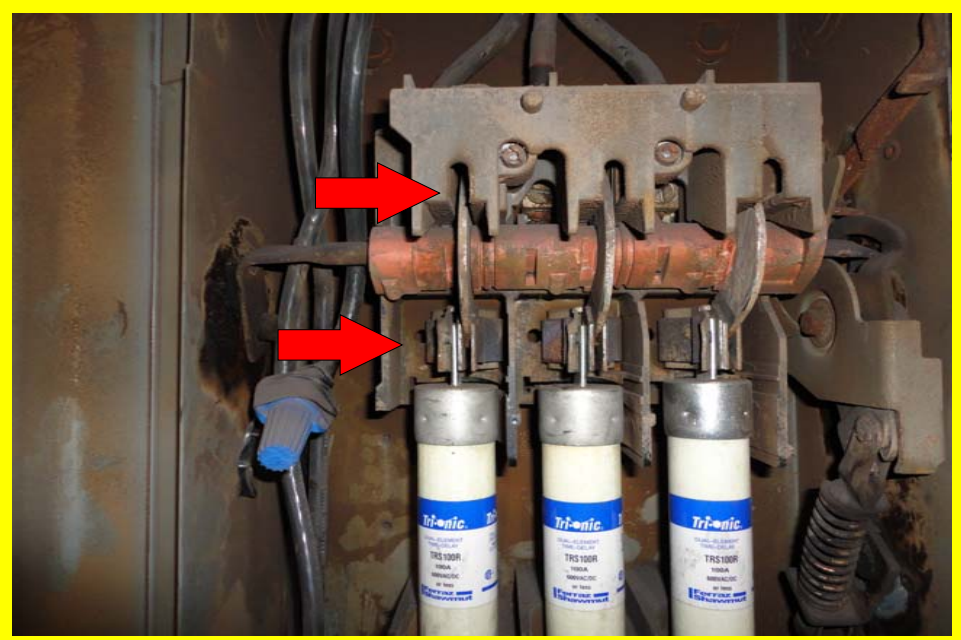
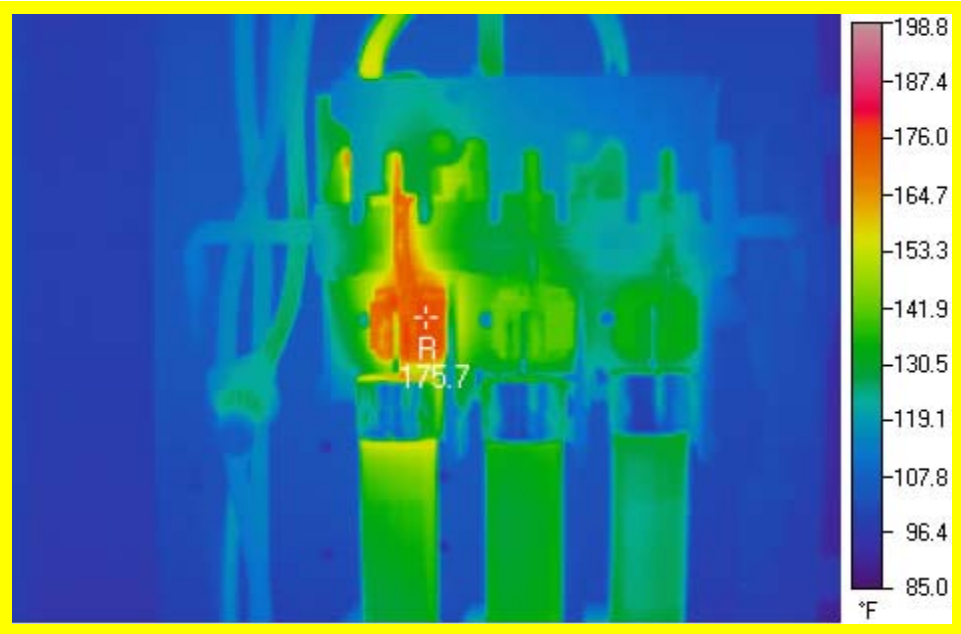
PROBLEM NO.20

**EQUIPMENT** : 100A Fused Disconnect Labeled: Pump No.3

**PROBLEM** : Line side, left  $\emptyset$  contact jaw / contact arm pivot point / fuse clip areas showing a 65°F rise over adjacent phases.  
**NOTE<sup>1</sup>**: Load removed at time of discovery  
**NOTE<sup>2</sup>**: Previous problem No.9 from report dated August 2010

**COMMENTS** : Clean, inspect, and tighten all associated contacting/connection points of disconnect assembly. Rebuild or replace entire disconnect
