**INFRARED INSPECTION REPORT SUMMARY**

CUSTOMER NAME	
Steel Casting Plant 1234 Main Street Anytown, USA 12345

DATE OF INSPECTION	July 12 through 14, 2011
INSPECTION PERFORMED BY	John Woska
ASSISTANCE PROVIDED BY	Vince of Scantek
SUGGESTED FOLLOW UP INSPECTION PERIOD	Three to Six Months

# THERMOGRAPHIC REPORT

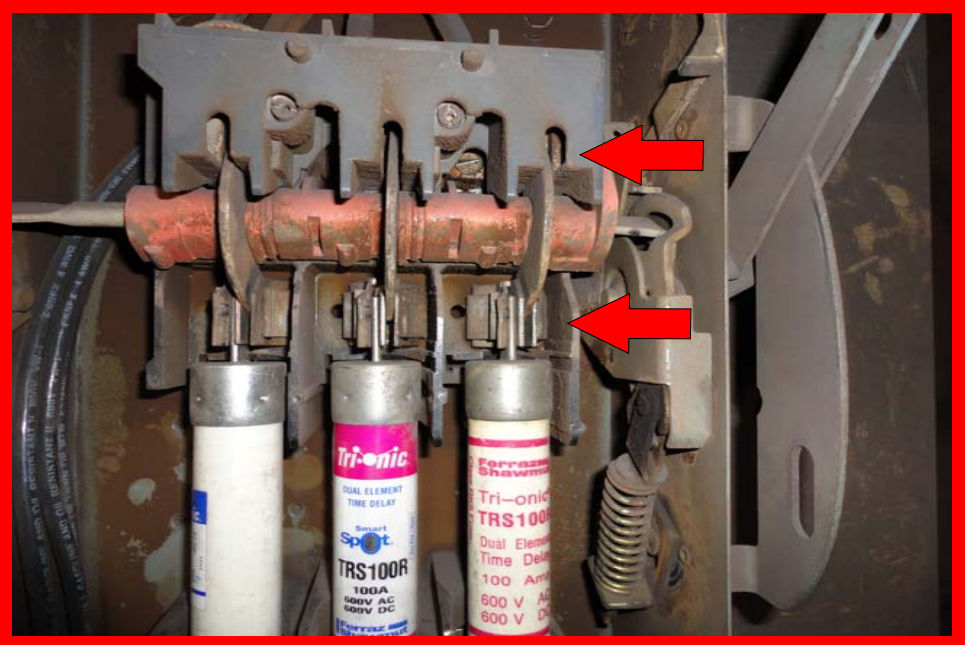
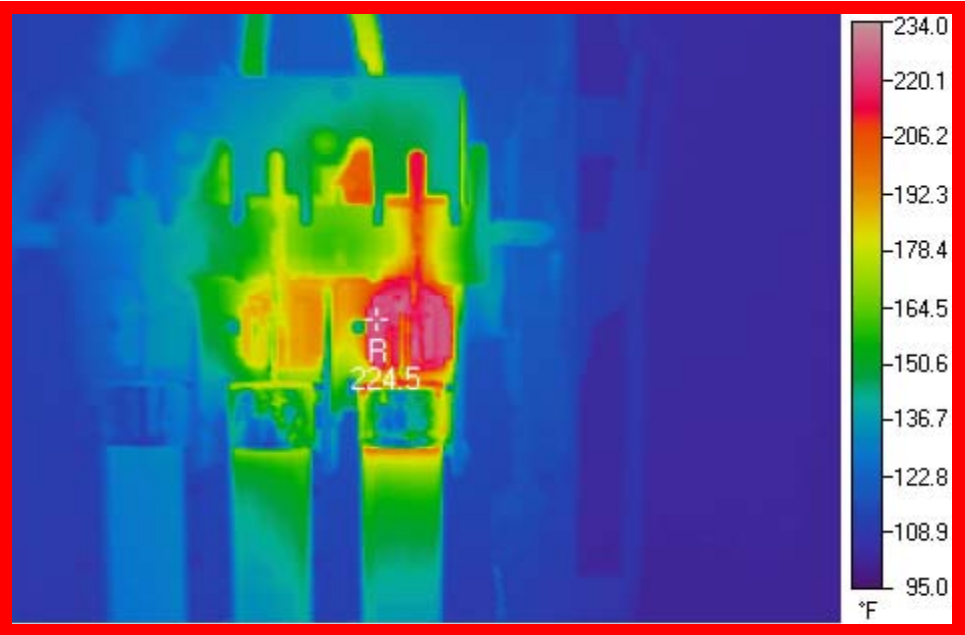
PROBLEM NO.21

**EQUIPMENT** : 100A Fused Disconnect Labeled: Pump No.4

**PROBLEM** : Line side, right  $\emptyset$  contact jaw / contact arm pivot point / fuse clip areas showing a 116°F rise over adjacent phases.  
**NOTE<sup>1</sup>**: Load removed at time of discovery  
**NOTE<sup>2</sup>**: Previous problem No.10 from report dated August 2010

**COMMENTS** : Clean, inspect, and tighten all associated contacting/connection points of disconnect assembly. Rebuild or replace entire disconnect

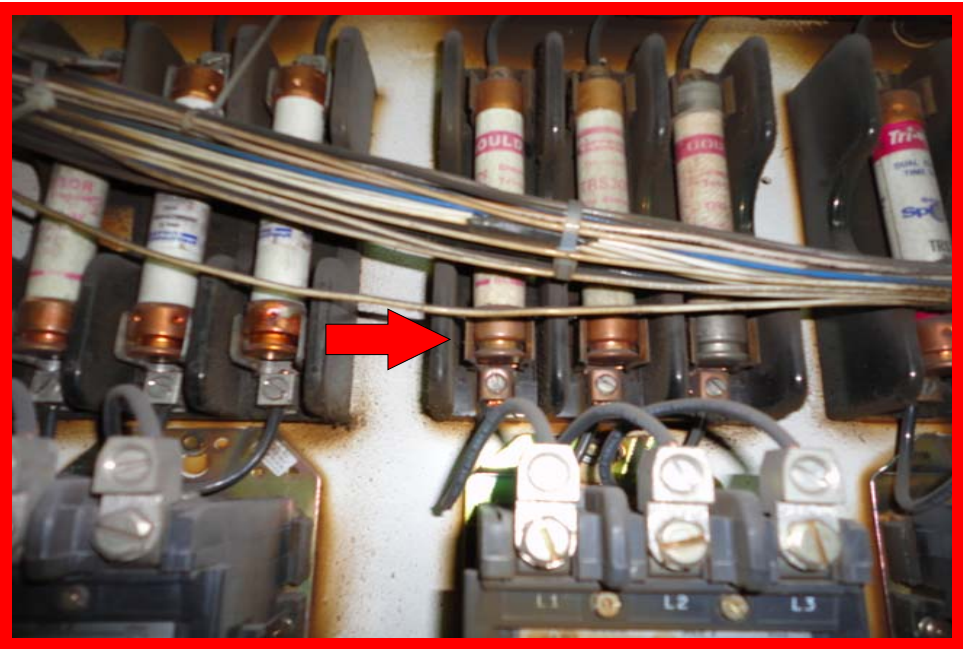
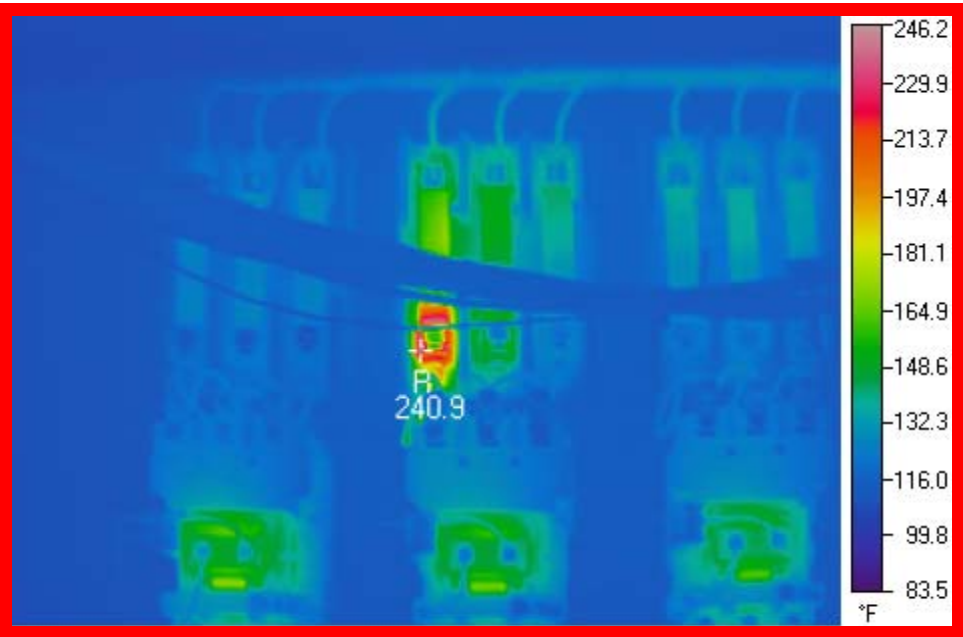
PROBLEM NO.22

**EQUIPMENT** : Large Motor Control Cabinet, Top Row, 2<sup>nd</sup> From Left Starter Fuse Set

**PROBLEM** : Load side, left  $\phi$  fuse clip area showing a 148 $^{\circ}$ F rise over adjacent phases at 15A loading

**COMMENTS** : Clean all fuse ends and clip surfaces and/or restore proper clip tension as required. Inspect, clean fuse clip surfaces, checking for fuse clip tension and fuse bracket screw(s) tightness

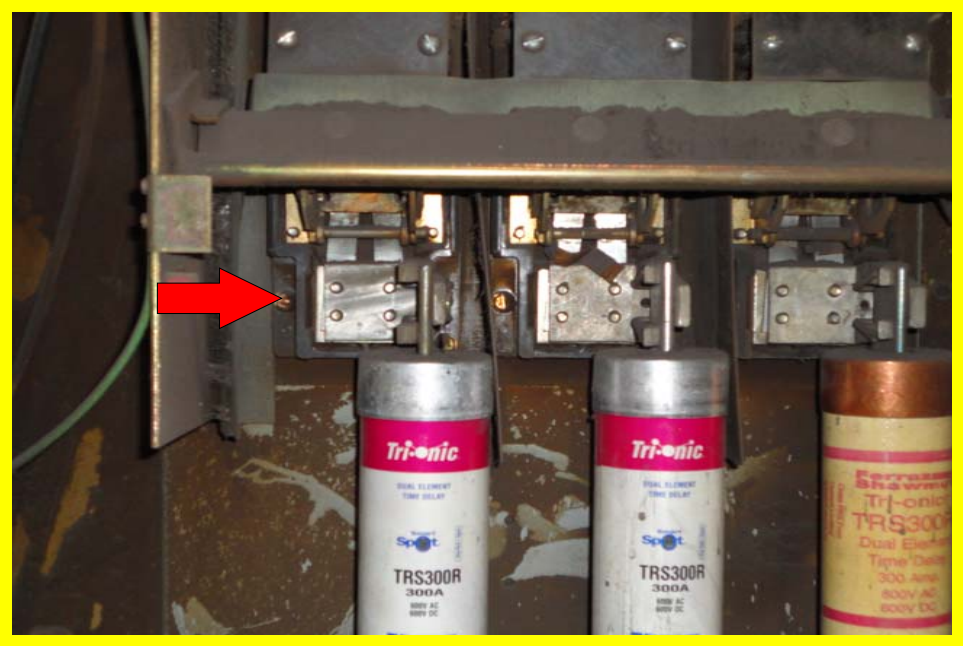
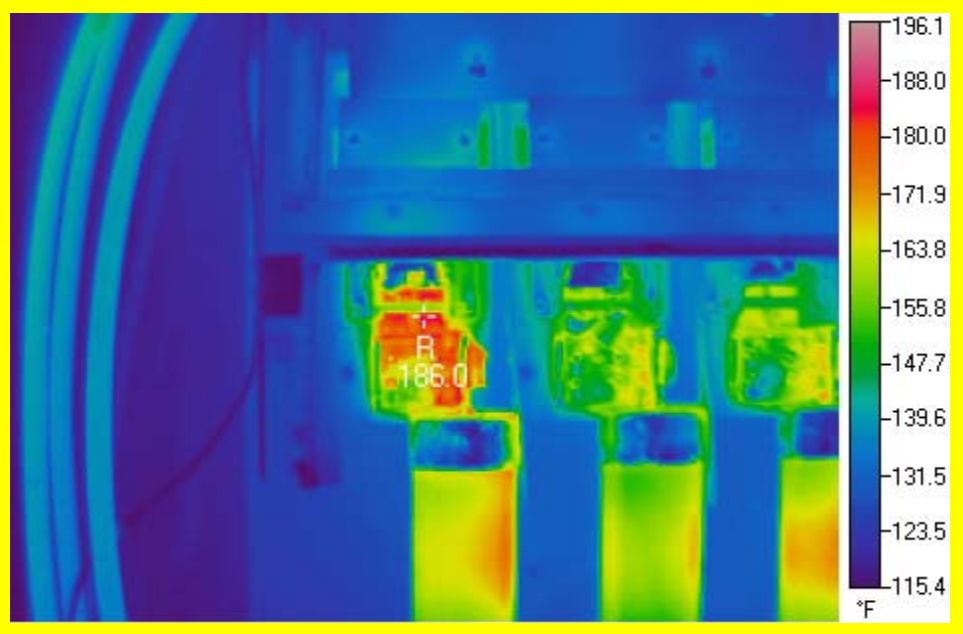
PROBLEM NO.23

- LOCATION** : Foundry Building, Air Compressor Area
- EQUIPMENT** : Inside 400A Fused Disconnect for Kwic Arc Air Compressor
- PROBLEM** : Line side, left  $\phi$  fuse clip / buss connection area showing a 35°F rise over adjacent phases at 220A loading.  
**NOTE:** Amperage reading at time of inspection: A $\phi$ :220, B $\phi$ :210, and C $\phi$ :221
- COMMENTS** : Clean all fuse ends and clip surfaces and/or restore proper clip tension as required. Disassemble, clean, dress all points, and reassemble torquing to spec.
- DATE & TIME** : 7/13/11 @ 3:38PM

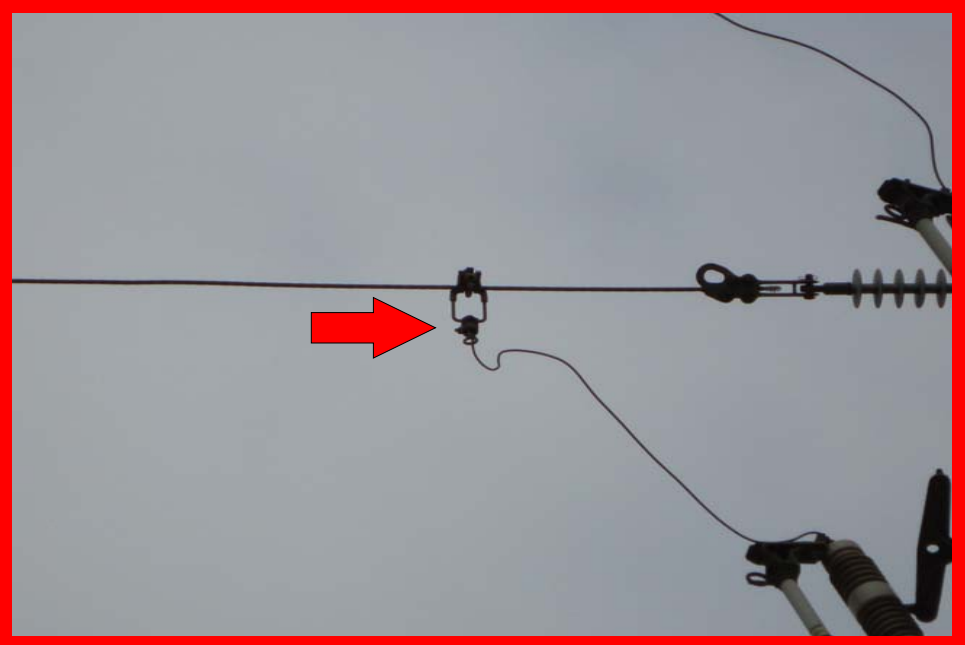
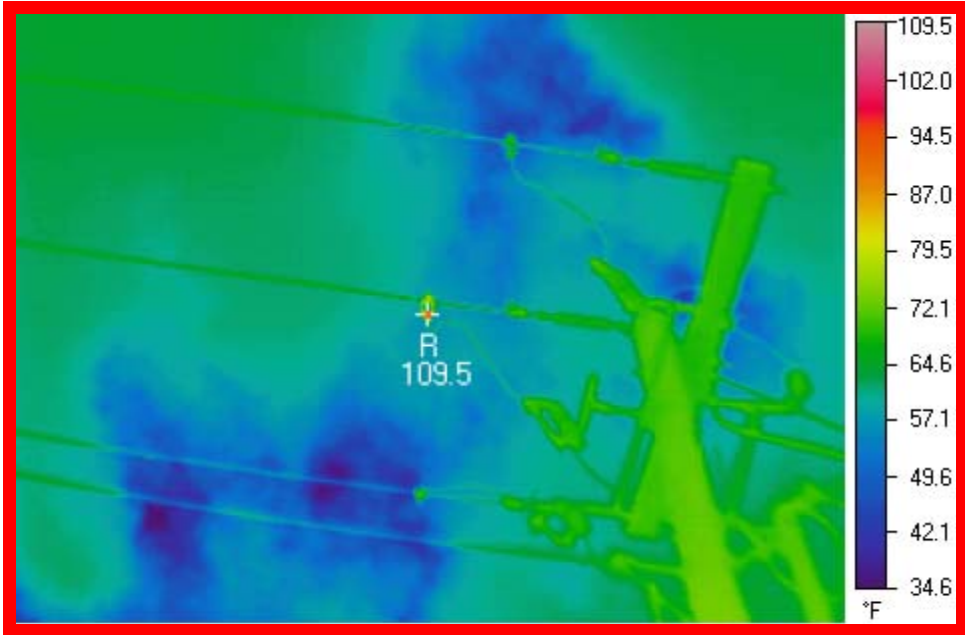
PROBLEM NO.24

**EQUIPMENT** : Power Pole Service Drop, Center ∅ Primary Hot Tap

**PROBLEM** : Indicated connection area showing a 39°F rise over adjacent phases

**COMMENTS** : Contact local utility company to inspect for cause of heating and repair or replace as required

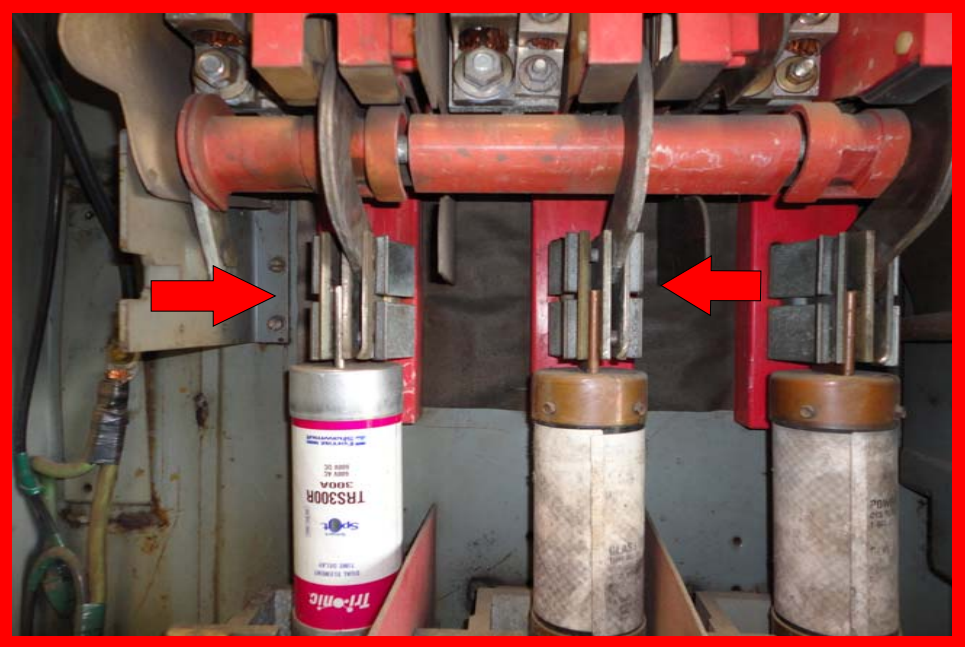
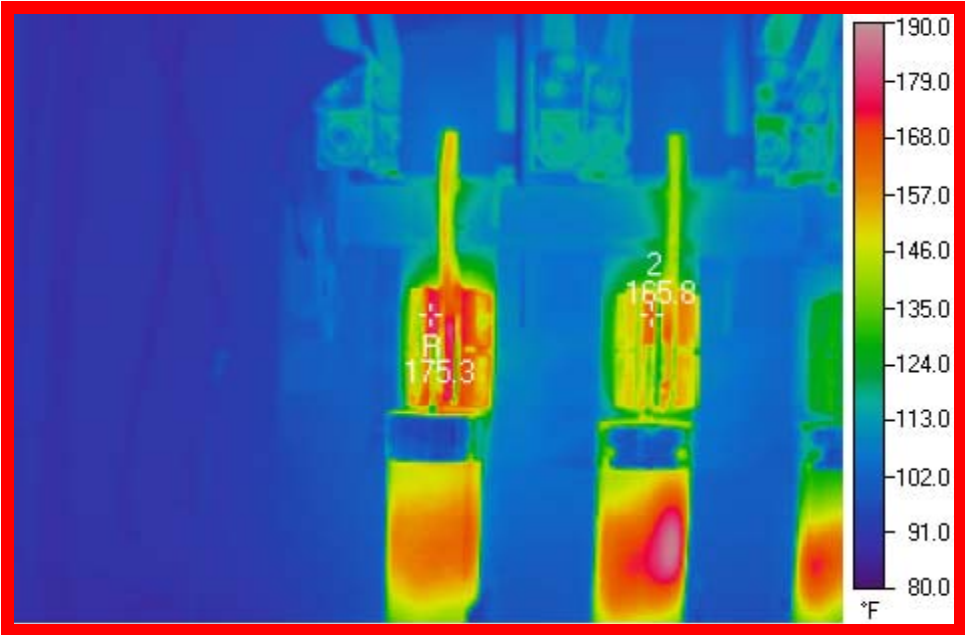
PROBLEM NO.25

- LOCATION** : Outside of Stone Building, West Corner
- EQUIPMENT** : Unlabeled Air Compressor 400A Fused Disconnect
- PROBLEM** : Line side, left  $\phi$  and center  $\phi$  contact arm pivot point / fuse clip areas showing 65°F to 70°F rises over adjacent phase.  
**NOTE<sup>1</sup>**: Amperage reading at time of inspection: A $\phi$ :275, B $\phi$ :285, and C $\phi$ :280  
**NOTE<sup>2</sup>**: Previous problem No.13 from report dated August 2010
- COMMENTS** : Clean, inspect, and tighten all associated contacting/connection points of disconnect assembly. Clean disconnect blade and jaw surfaces and restore proper tension as required
- DATE & TIME** : 7/14/11 @ 11:22AM

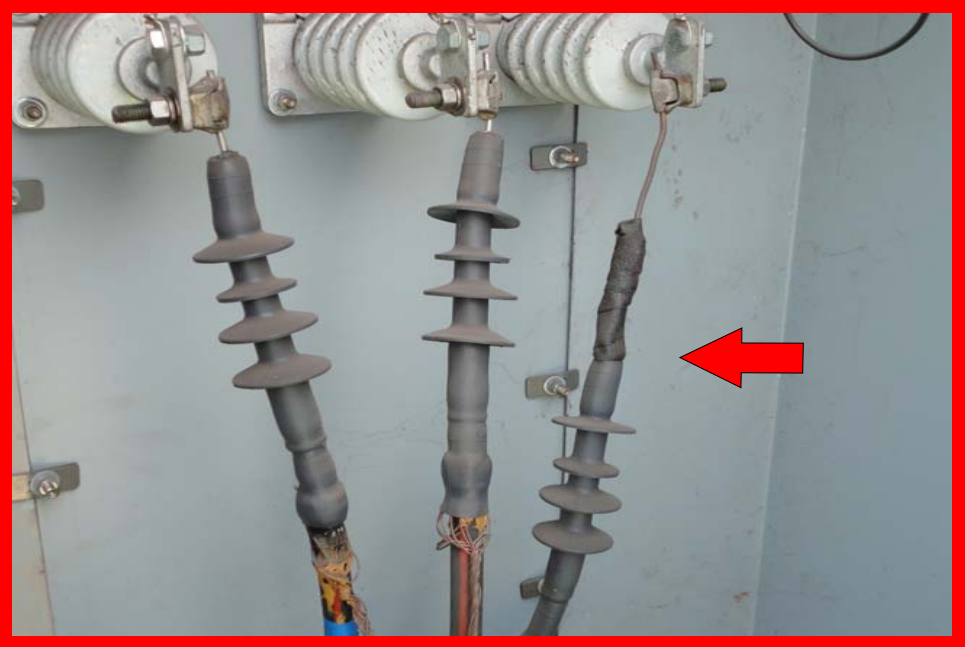
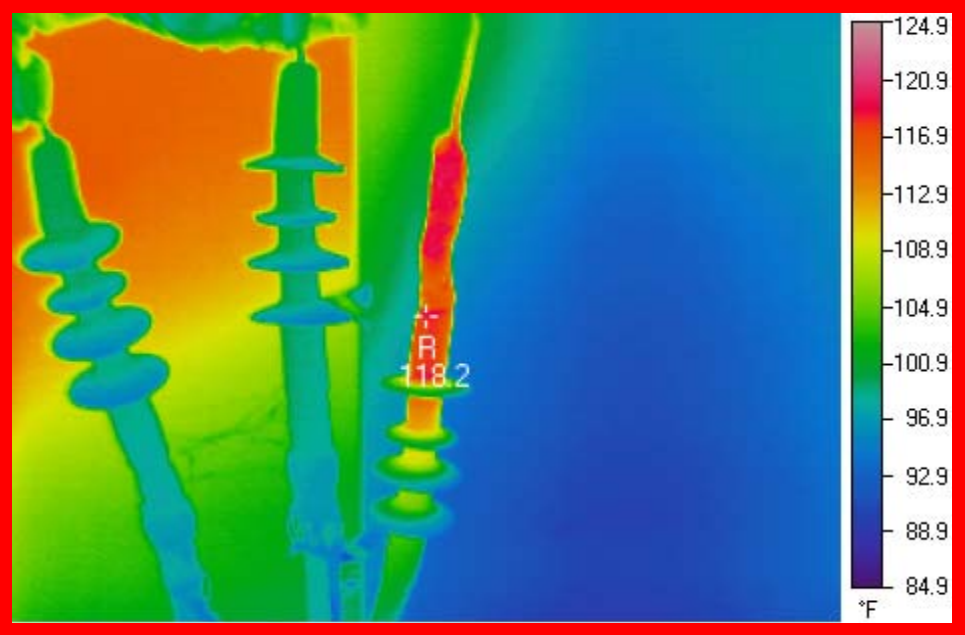
PROBLEM NO.26

**EQUIPMENT** : Areva 1650kVA Transformer, Primary Bay Bushing Set, No.H-1 Conductor

**PROBLEM** : Indicated conductor stress cone area showing a 13°F rise over adjacent phases.  
**NOTE<sup>1</sup>**: Furnace turned off for ten minutes at time of discovery  
**NOTE<sup>2</sup>**: Previous problem No.12 from report dated August 2010

**COMMENTS** : Suggest putting lock on transformer doors. Inspect for cause of heating and repair or replace as required. Replace affected conductor
